2023年2月6日に発生したトルコ巨大地震の現地調査報告

2023 TÜRKİYE EARTHQUAKES: Observations and Lessons

藍檀 オメル/Ömer AYDAN

琉球大学 工学部 名誉教授

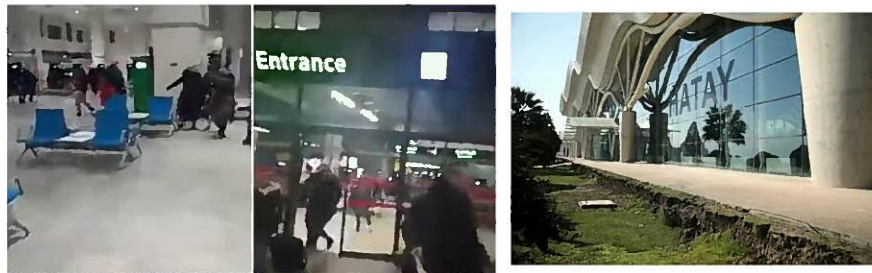
Hatay Airport ・ 空港

The runway of Hatay airport buckled

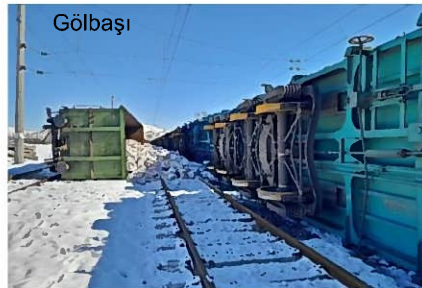
Buckling of rails due to faulting and ground deformation, toppling of trains

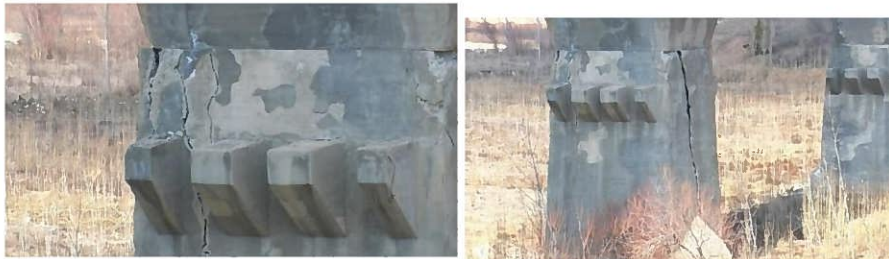
Istanbul-Bağdat Railway Line

Heavy splitting cracks of piers near foundations

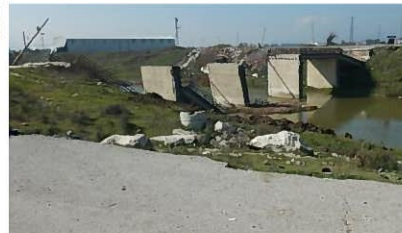
Bridge collapse due to pier settlement due to ground failure (Antakya)

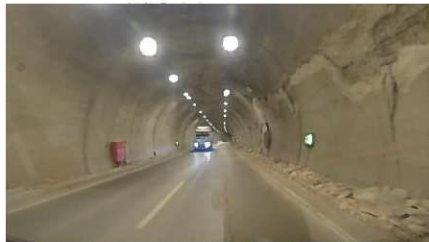
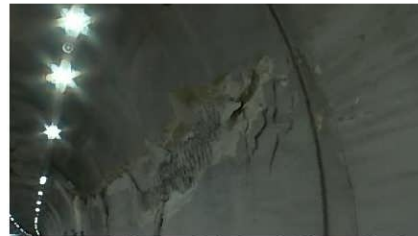
Collapse of concrete lining occurred despite they were reinforced.

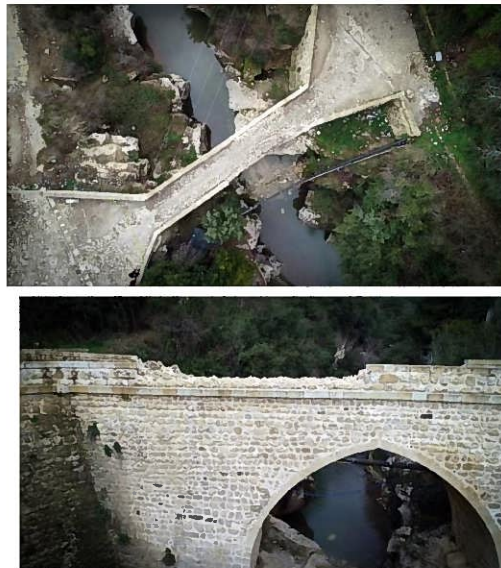
Batıyaz Taş Köprü

They are structurally stable despite some dislocation of rock blocks.

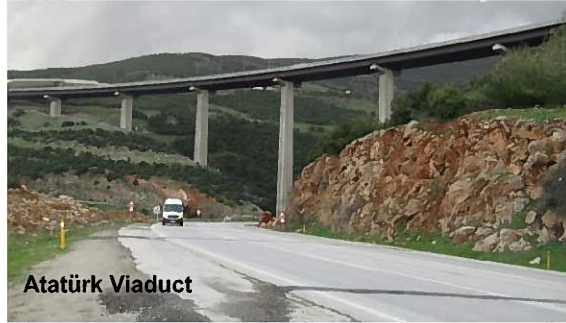
No damage despite close proximity fault ruptures

They are built as redundant structures with continuous steel girders

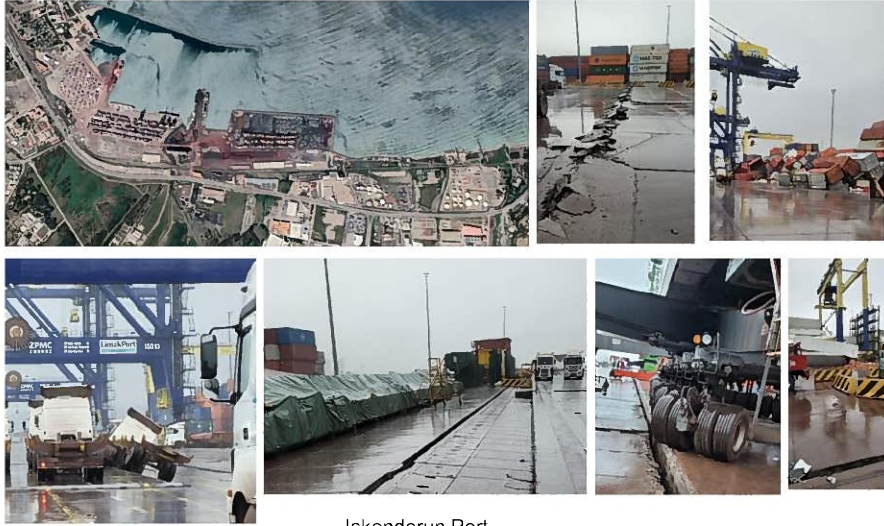
Iskenderun Port

Structural Damage is small: Small settlement, pounding, separation etc.

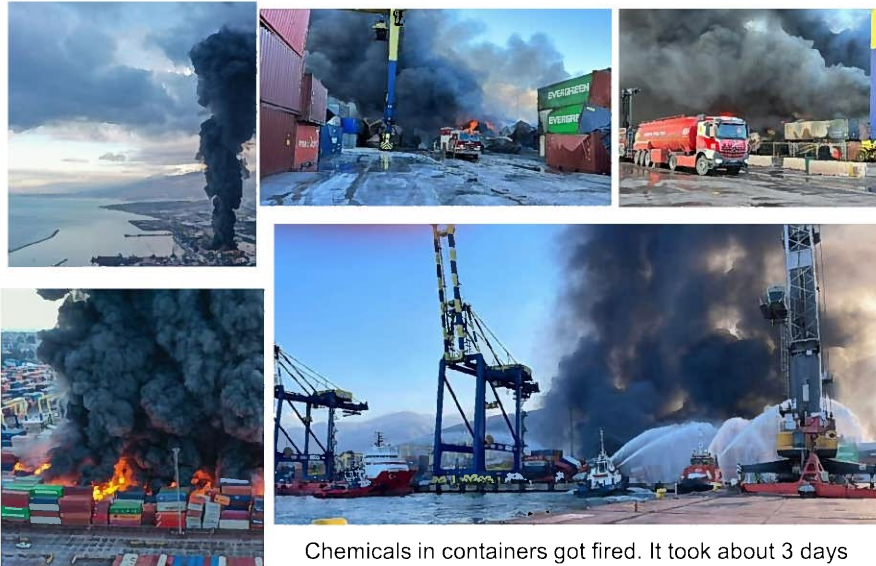
火災 ・ Fires at Iskenderun Port

Chemicals in containers got fired. It took about 3 days to extinguish fires.

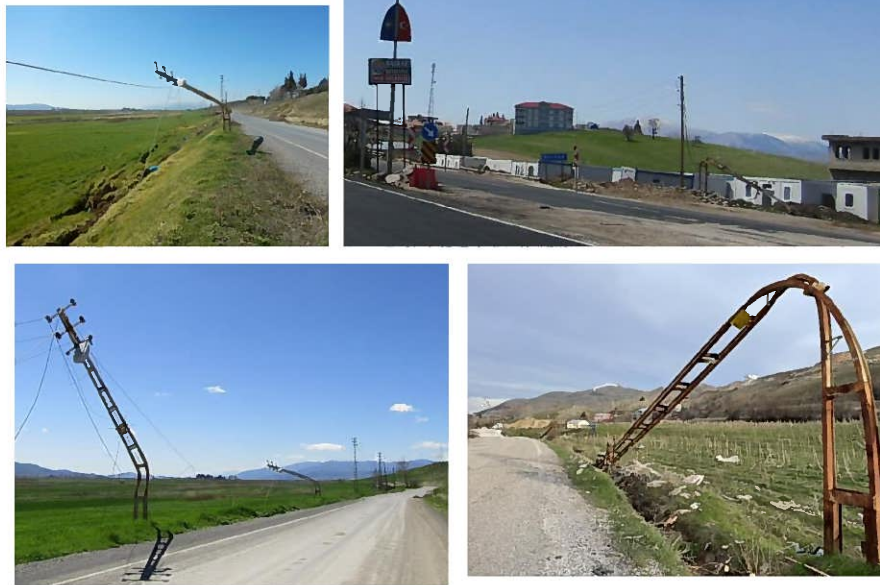
電信柱の座屈・ Bended buckled steel utility poles due to high strong motions

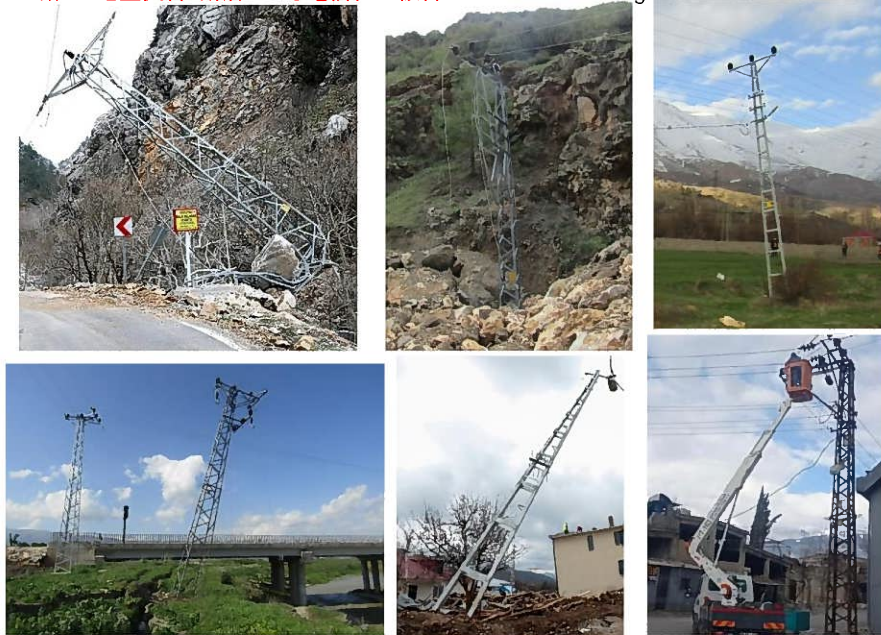
落石・地盤災害・断層による電信柱の被害 ・ Failure or Tilting of Steel Utility Poles

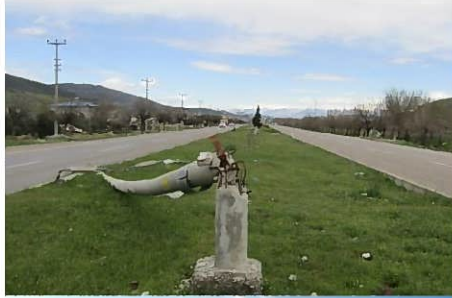
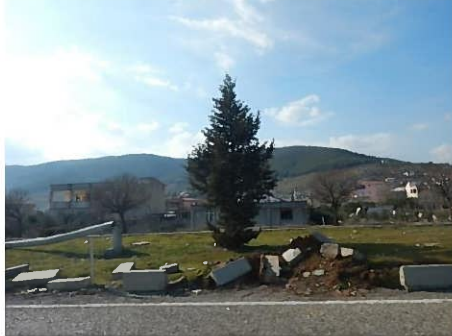
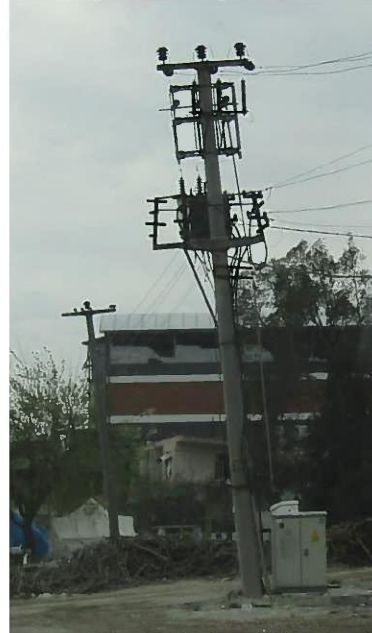
RC電信柱の被害 ・ Failure or Tilting of RC Utility Poles

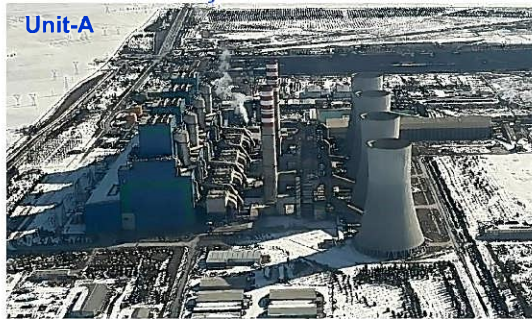
Afşin-Elbistan Thermal Power Plant ・ 火力発電所

Minor damage. However, some replacements of old and slightly damaged components have been implemented.

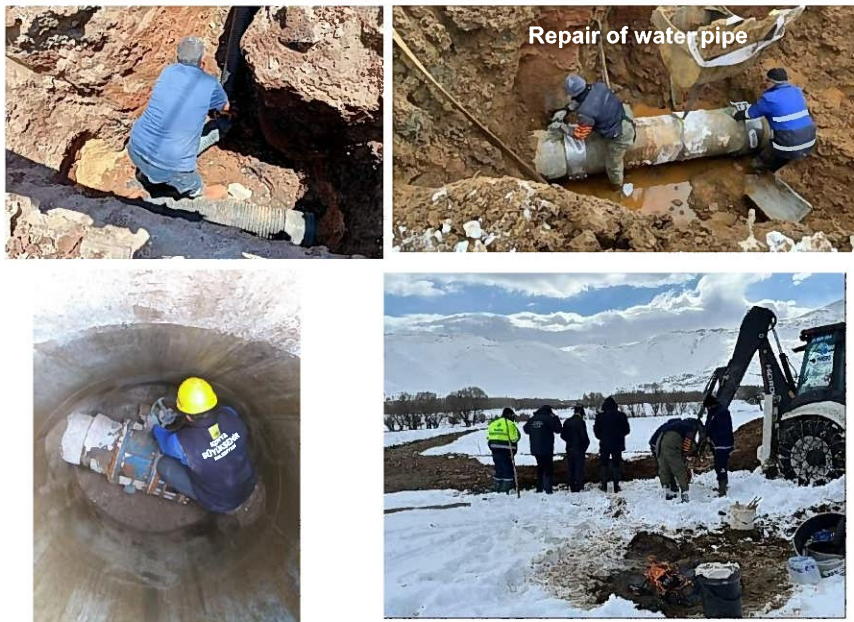
水道パイプの被害 ・ Water Pipe Damage and Repairs

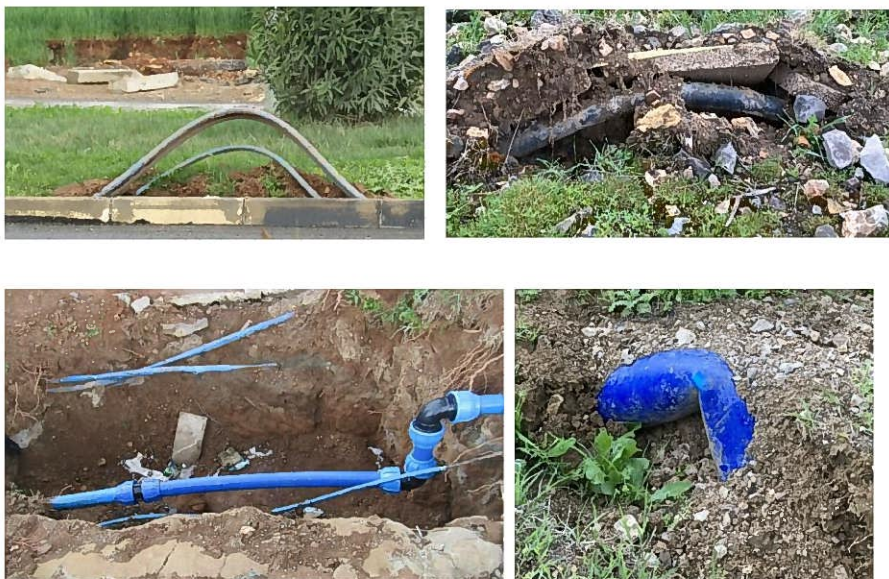
水道パイプの被害 ・ Water Pipe Damage

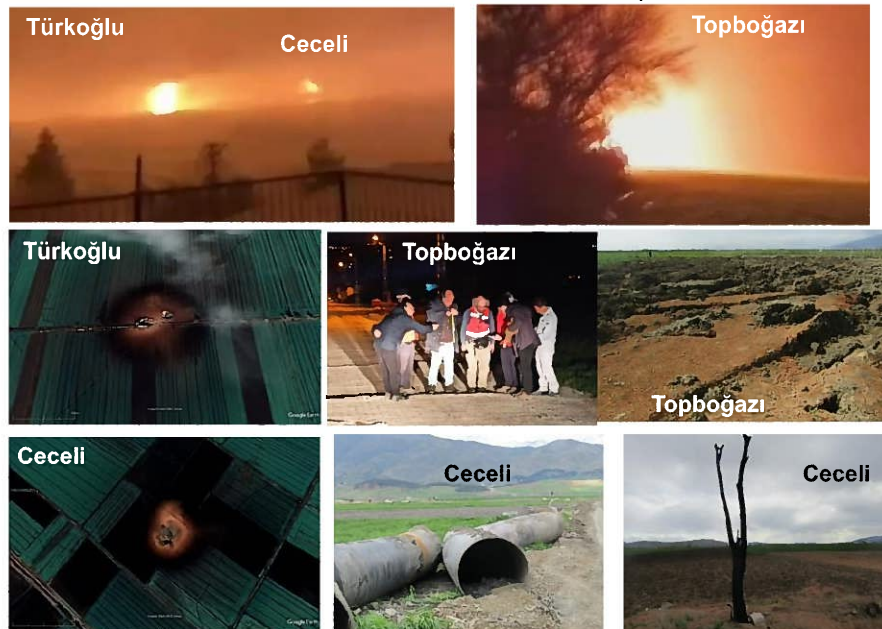
天然ガスパイプラインの爆発 ・ Natural Gas Pipeline Fires

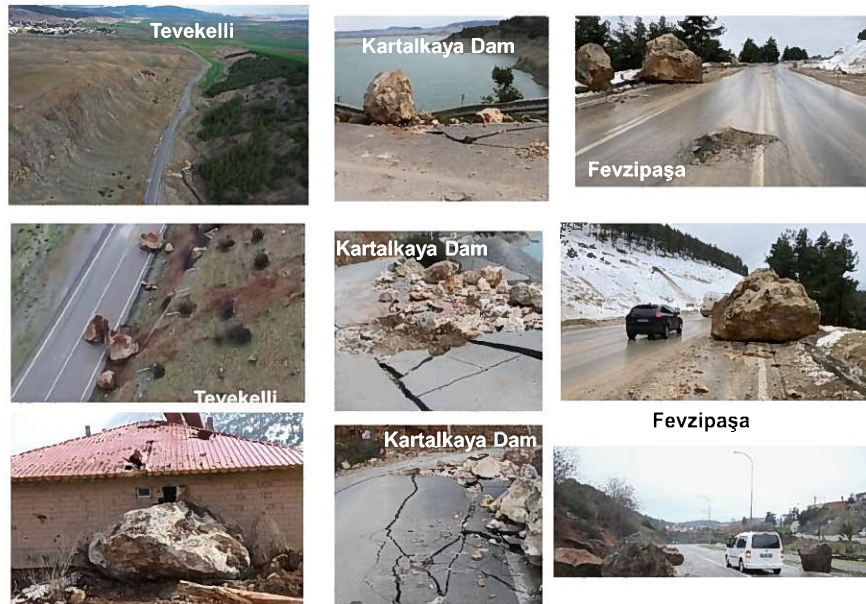
地盤被害 ・ GEOTECHNICAL DAMAGES
 落石 ・ Rockfalls

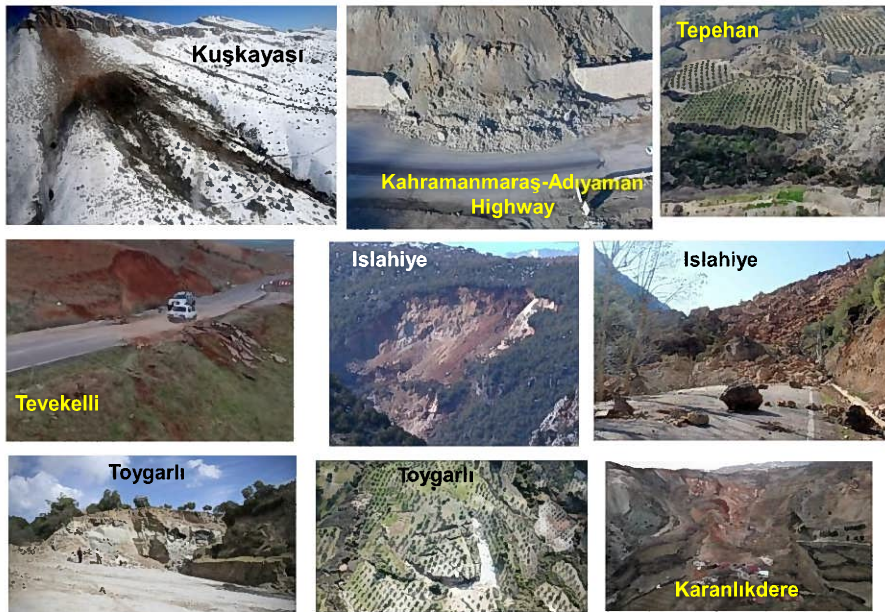
地滑り ・ Slope Failures (Landslides)

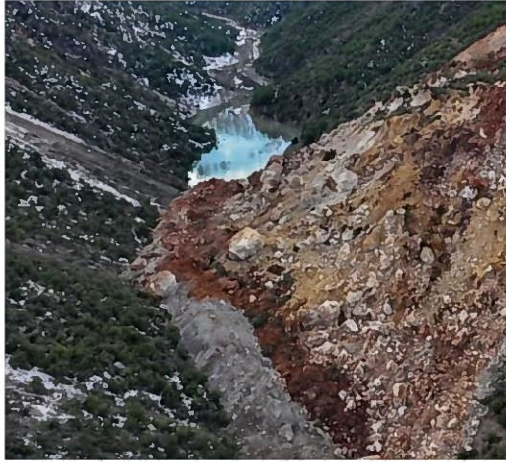
地滑りダム ・ Landslide Dams

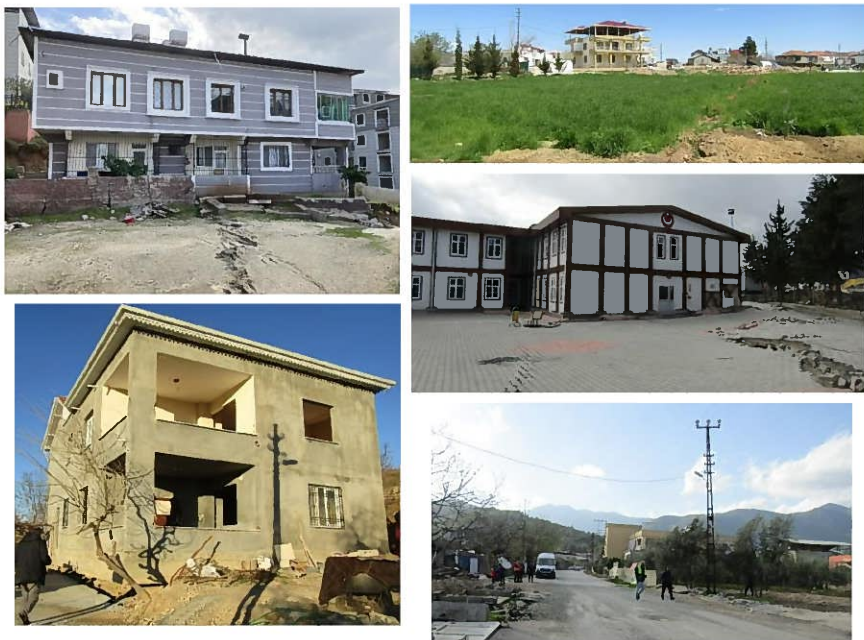
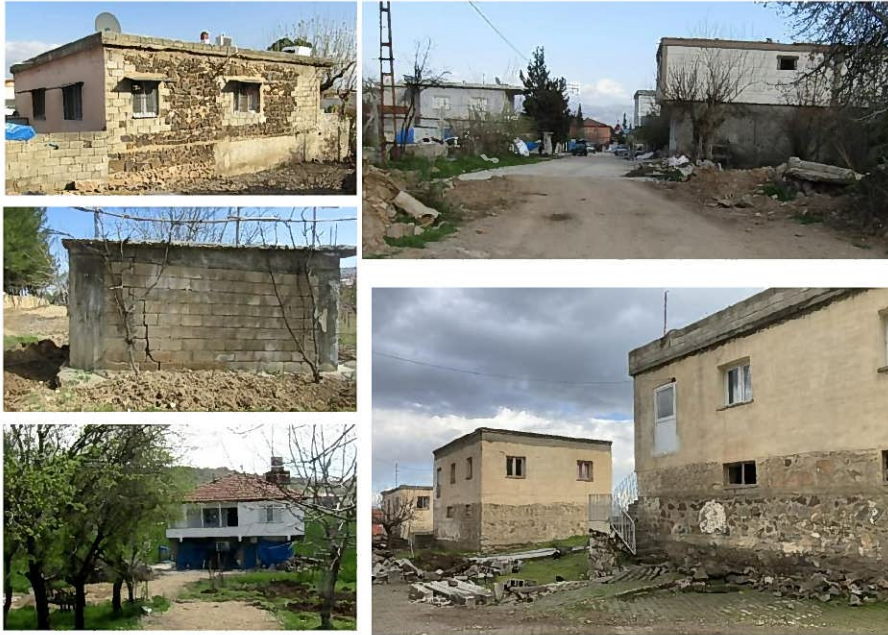
地表面断層の建物被害への影響・INTERACTION BETWEEN FAULTS AND BUILDINGS

The quality of construction and foundation type are not appropriate

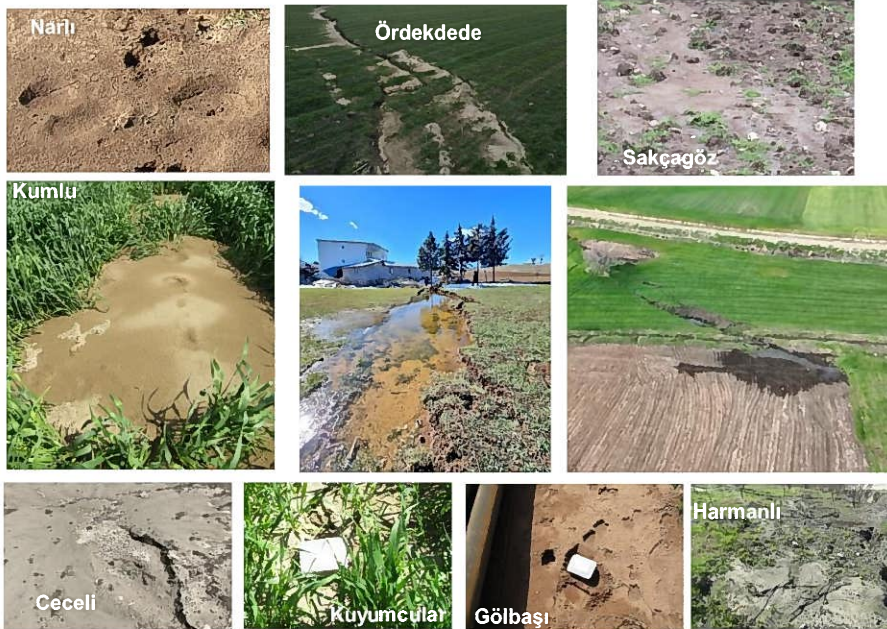
EFFECT OF FAULTING ON LIQUEFACTION RELATED SANDBOILS

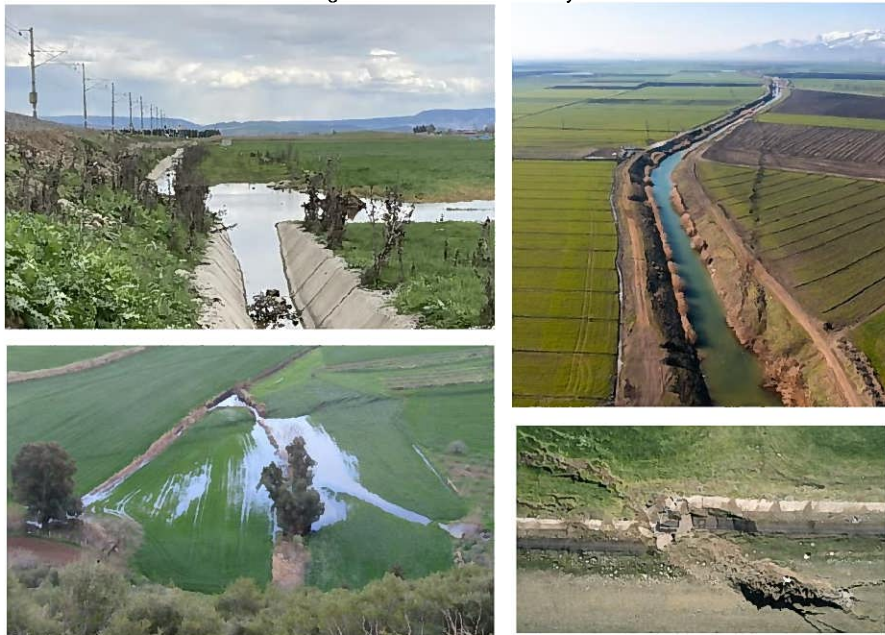
Damage to Canals - Waterways
