2023年2月6日に発生したトルコ巨大地震の現地調査報告

2023 TÜRKİYE EARTHQUAKES: Observations and Lessons

藍檀 オメル/Ömer AYDAN

琉球大学 工学部 名誉教授

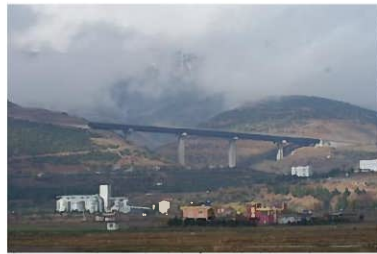
Turgut Özal Viaduct

No damage despite close proximity fault ruptures

They are built as redundant structures with continuous steel girders
