2023年2月6日に発生したトルコ巨大地震の現地調査報告

2023 TÜRKİYE EARTHQUAKES: Observations and Lessons

藍檀 オメル/Ömer AYDAN

琉球大学 工学部 名誉教授

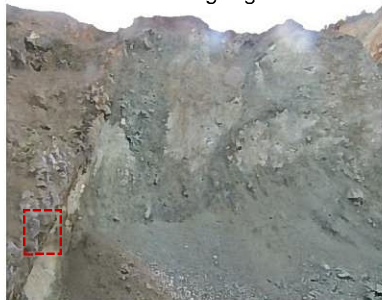
Striation and gouge

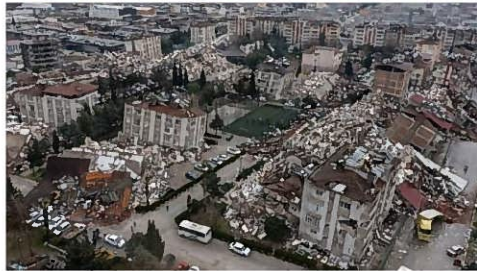
Antakya (Hatay)

Buildings toppled in opposite direction against ground movement (Newton's law of action-reaction)

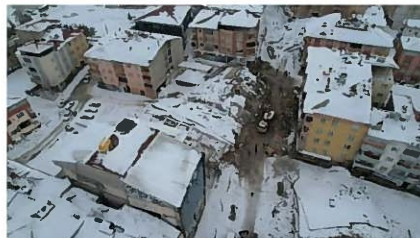
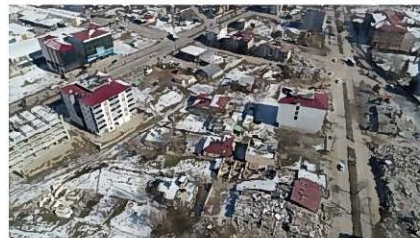
Elbistan

(damaged by Ekinözü Earthquake)

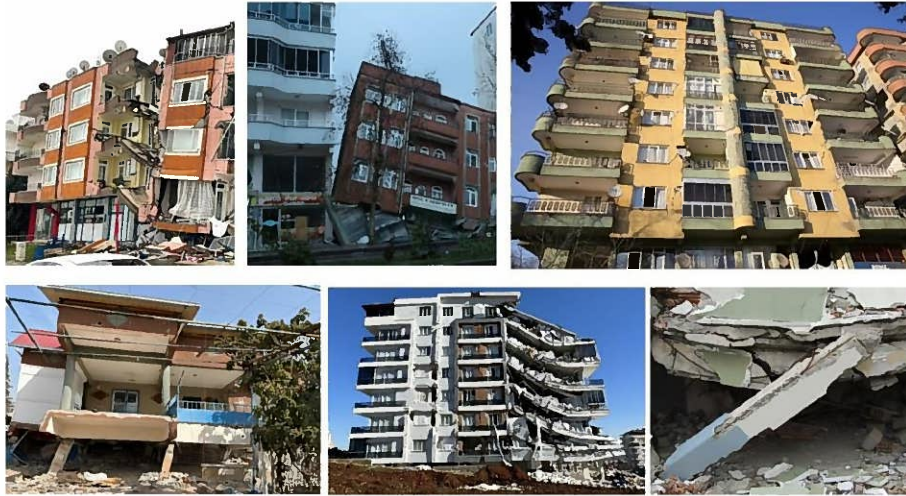
建物の損傷および破壊要因 ・ Causes of Damage and Collapse

Not obeying the Turkish Seismic Code

Poor workmanship

Construction negligence and lack of moral

Resonance

Soft Story

Pounding of adjacent structures

The causes remain to be the same since 1992 Erzincan earthquake

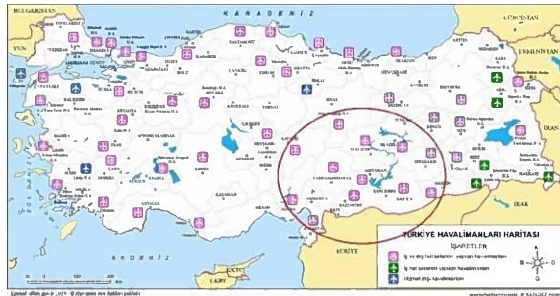
The circle indicates the airports in the epicentral area

Gaziantep Airport is shown at the time of Pazarcık earthquake occurred. Note the small pieces of debris falling from the **suspended ceilings**. Similar situations occurred at Kahramanmaraş and Malatya Airports.

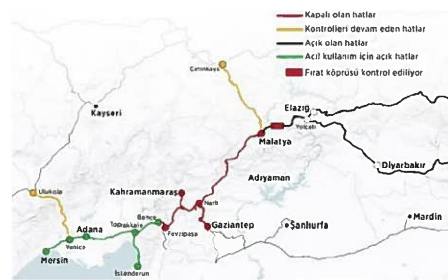
Locations of the damaged railway lines (from TCDD)

Damage was mainly caused by deformation of rails wherever they are crossed by earthquake faults.

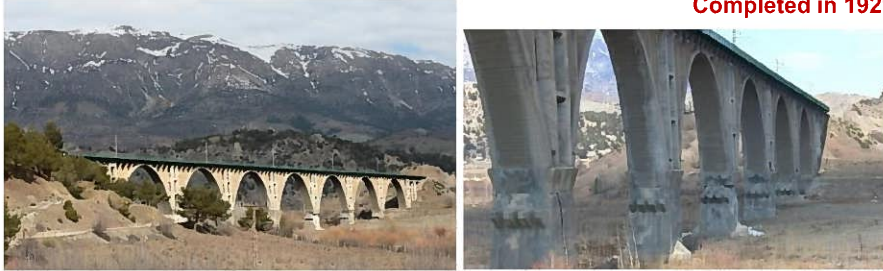
Göksu Abdülhamit-Han Bridge

Completed in 1929

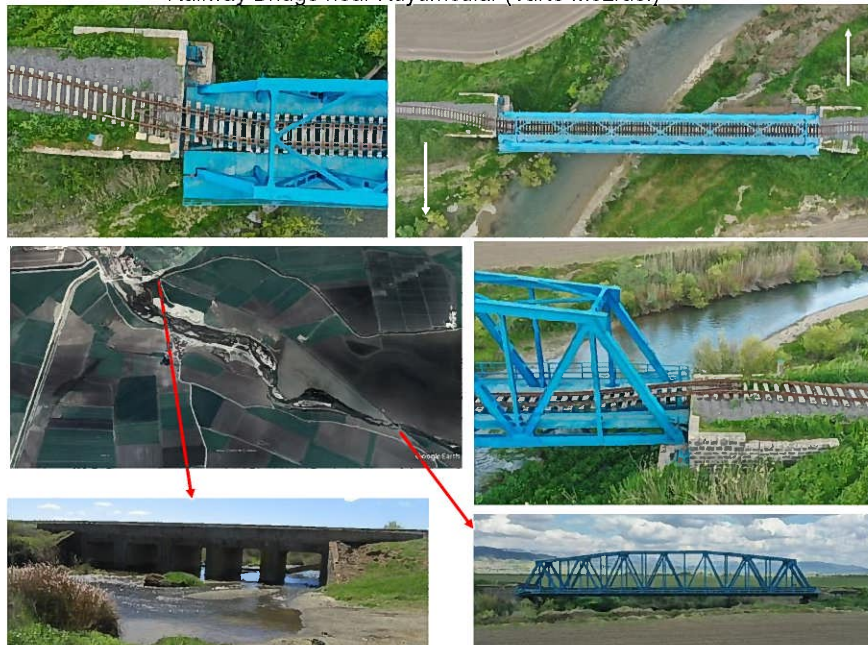
Railway Bridge near Kuyumcular (Varto Mezrası)

Heavy splitting cracks of piers near foundations

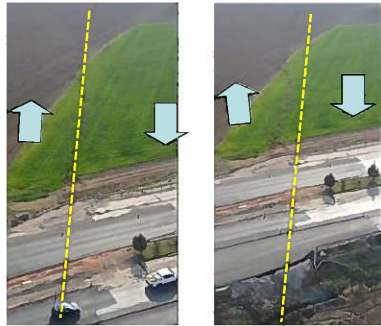
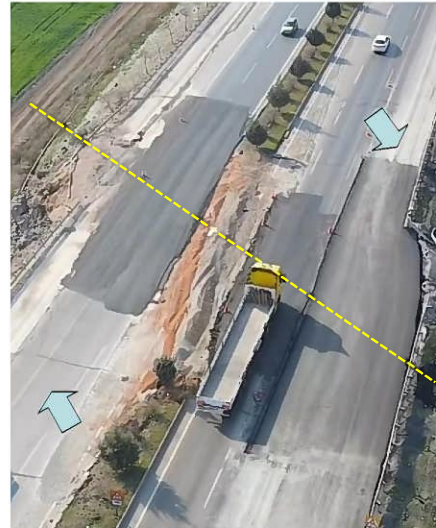
TAG Expressway

Roadways and railways should not be elevated and they should be constructed on the existing ground surface in active fault zones.

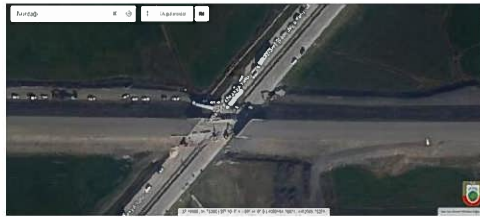
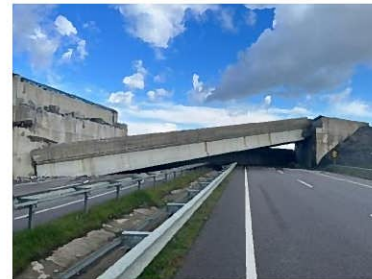
Bridges Nurdağı-Gaziantep Highway

Overpass Bridge collapsed due to permanent ground movements

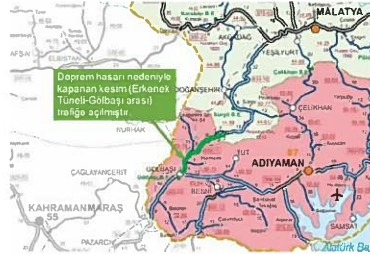
Location of Erkenek tunnel
Old Erkenek Tunnel is 330m long and unsupported
New Erkenek Tunnels are 1816 m long

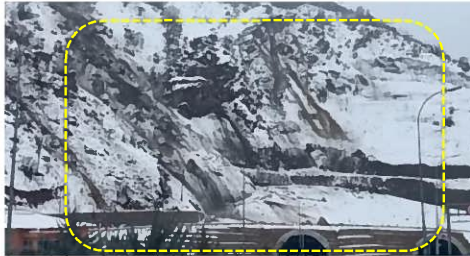
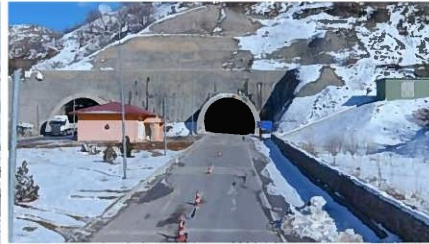
Traces and Rockfalls above the portals of new Erkenek tunnels

Spalling of concrete linings in New Erkenek Tunnels

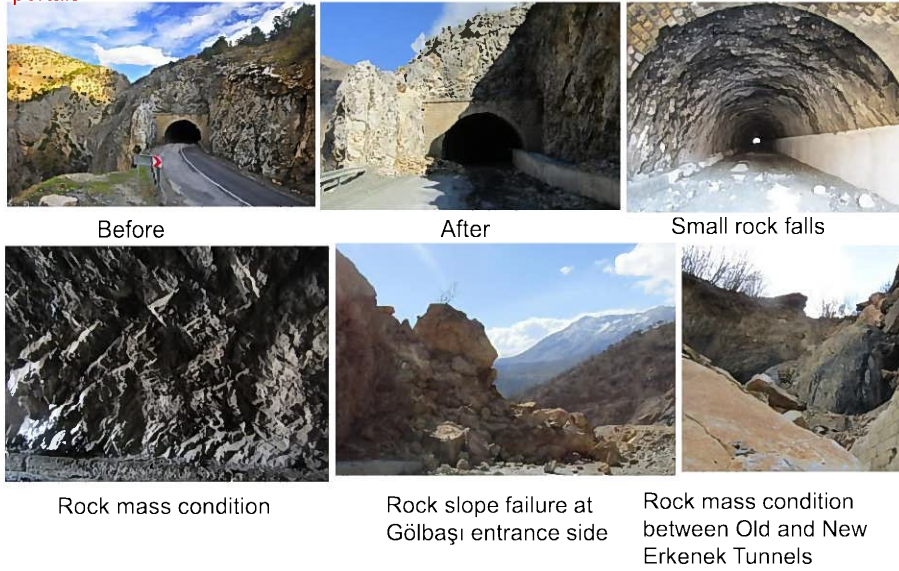
Portal and block falls in Old Erkenek Tunnels

Old Erkenek Tunnel excavated in limestone is 330m long and unsupported except portals

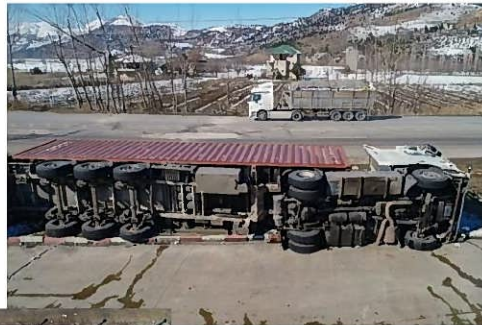
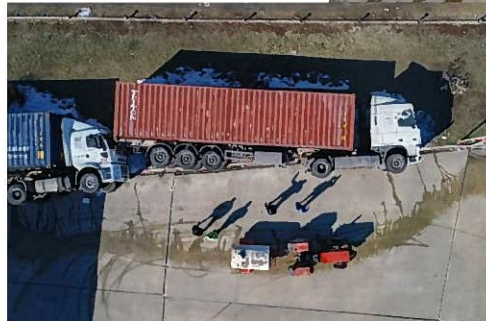
Adiyaman-Malatya highway

静止しているトラックの転倒 ・ Toppled stationary vehicles

Implying high ground motions

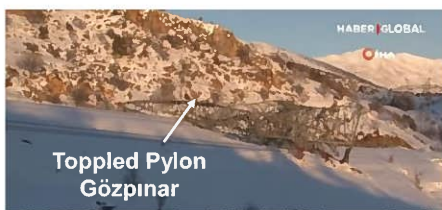
**Toppled Pylon
Gözpinar**

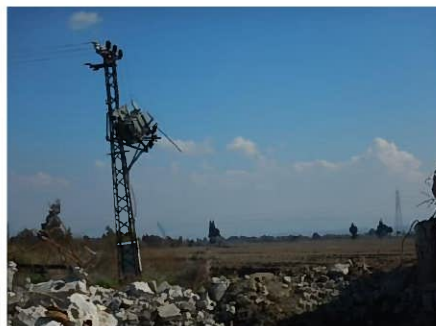
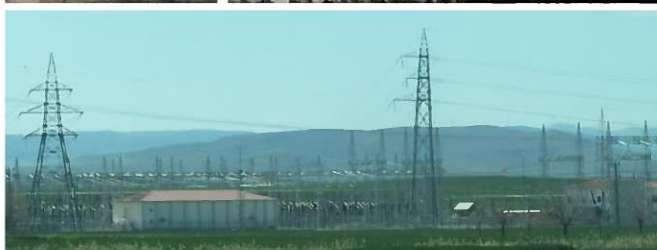
Dislocated or toppled transformers

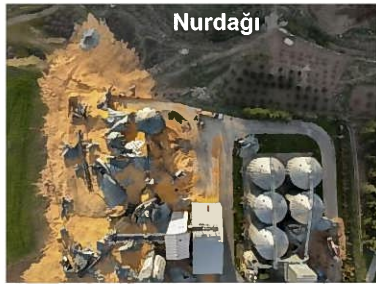
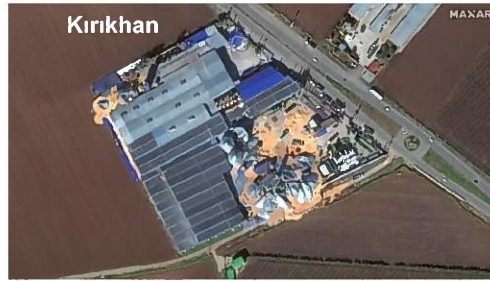
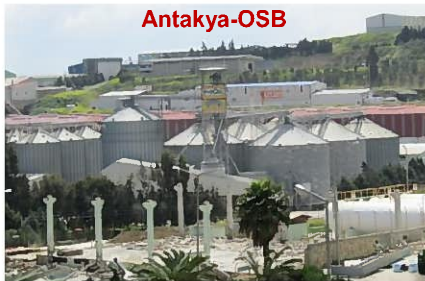
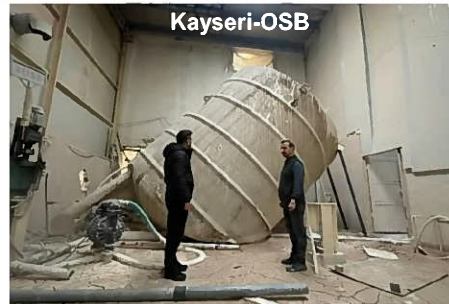
火災 ・ Fires

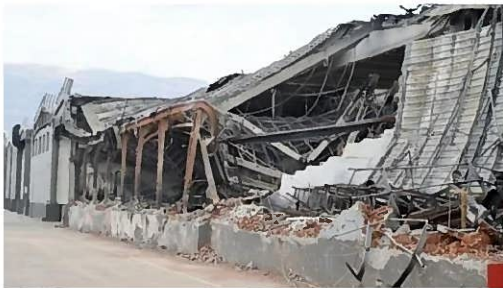
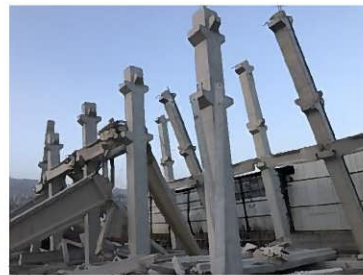
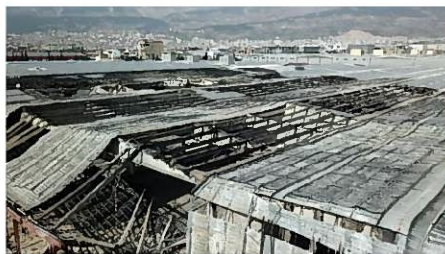
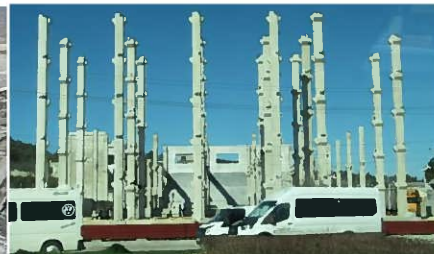
天井落盤 ・ Roof-Beam Collapses

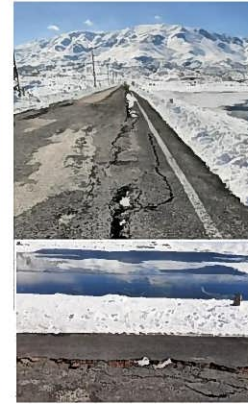
Atatürk Dam

Longitudinal Separation cracks between clay core and rock/earth fill

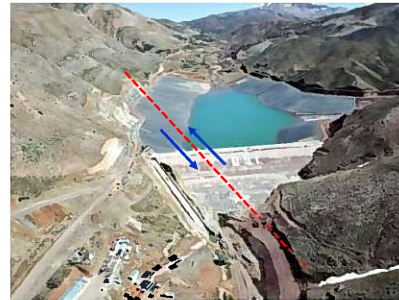
ERKENEK DAM ・ 被害 Partial rupture of Erkenek segment (65km)

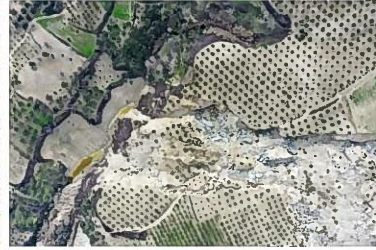
Tepehan

地滑りダム ・ Landslide Dams

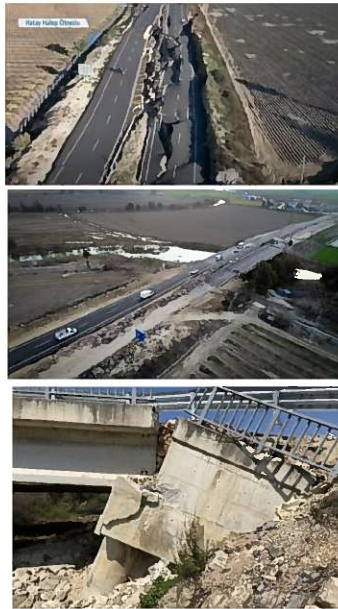
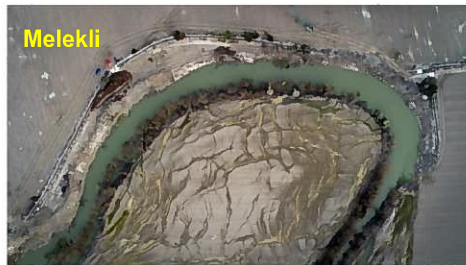
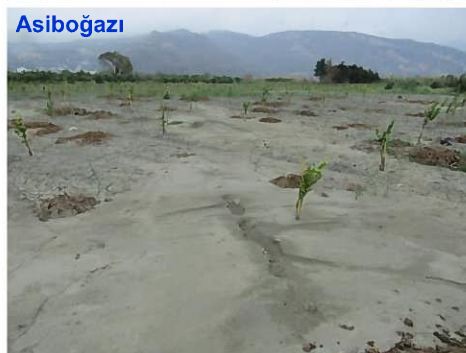
Antakya-Reyhanlı Highway

液状化 & 側方流動 ・ Liquefaction and Lateral Spreading

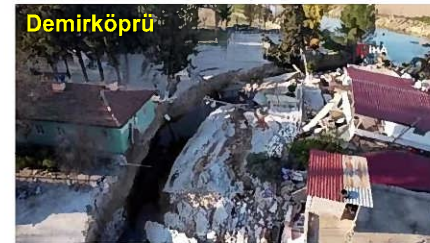
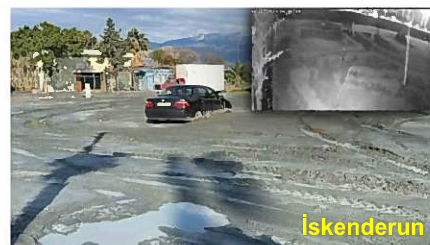
Gölbasi

液状化による建物の被害 ・ EFFECT OF LIQUEFACTION ON BUILDINGS

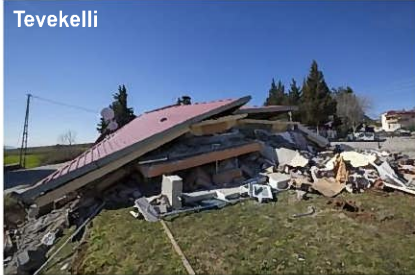
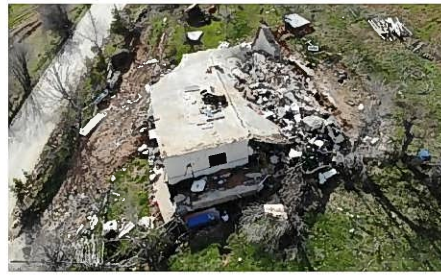
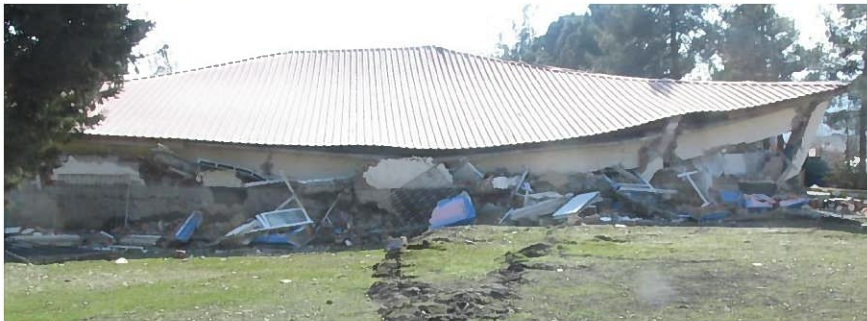
Tevekelli

The quality of construction and foundation type are not appropriate

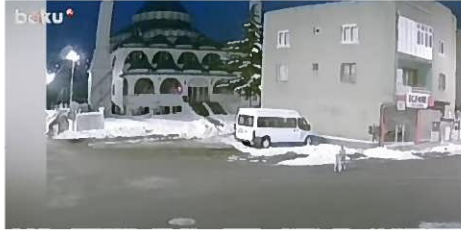
犬が吠える Barking dogs just before the earthquake
